**AC NO:** AC 20-64

# ADVISORY CIRCULAR

## DEPARTMENT OF TRANSPORTATION FEDERAL AVIATION ADMINISTRATION

**SUBJECT:** MAINTENANCE INSPECTION NOTES FOR LOCKHEED L-188  
SERIES AIRCRAFT

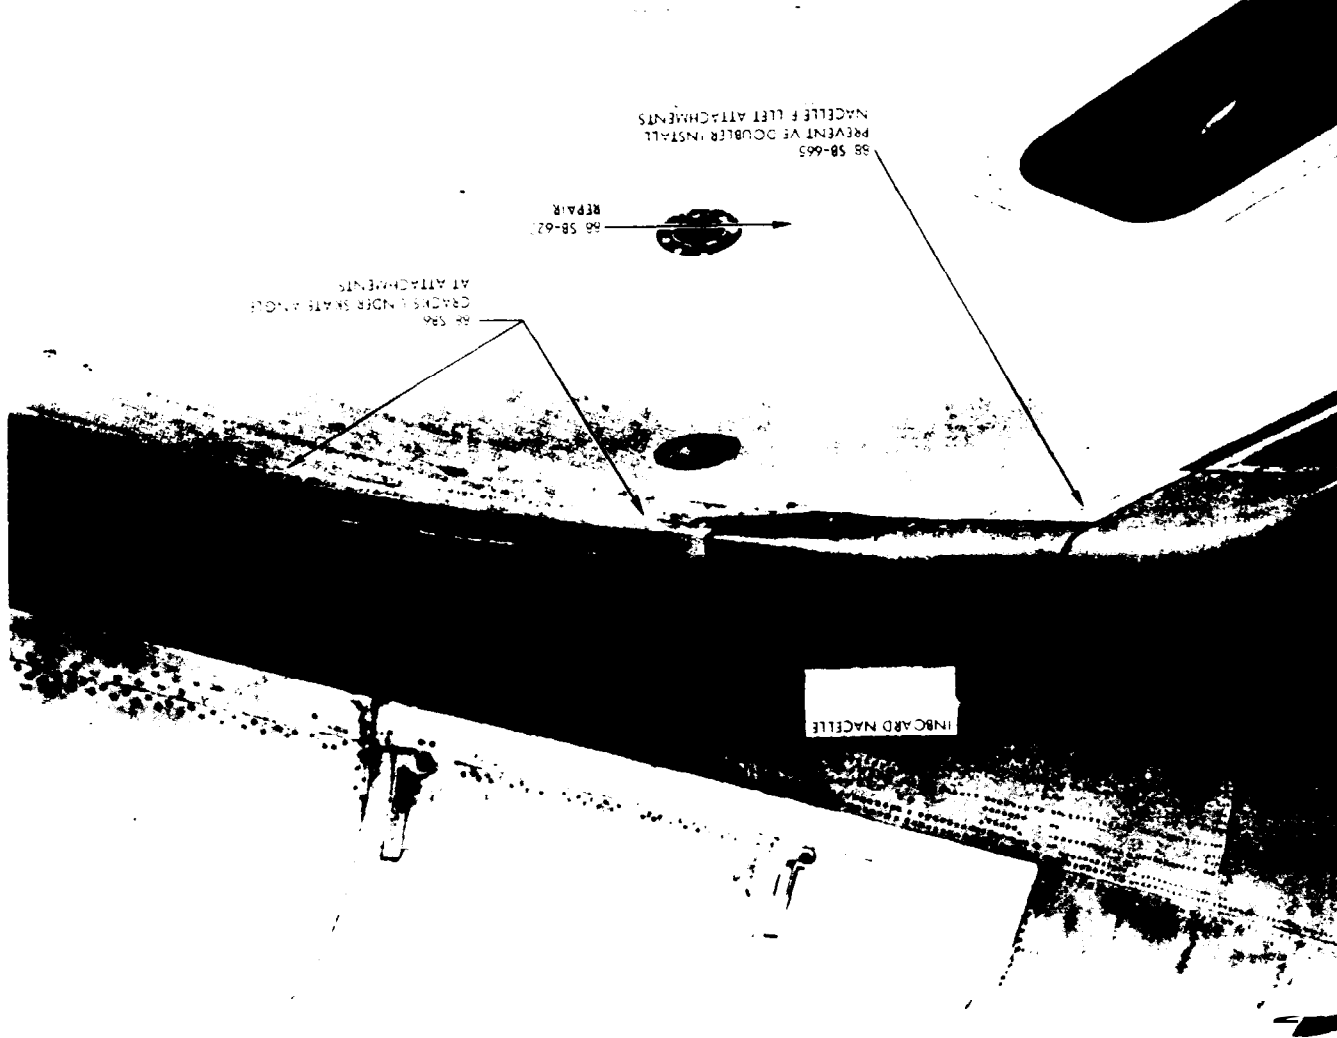
FIGURE F-12. WING UPPER SURFACE  
Reference W-7, page 12  
W-10, page 14  
W-25, page 22

1	2	3	4	5	6
NO.	MAJOR ASSEMBLY	ITEM	SERVICE HISTORY	PAGE REF. FOR ILLUSTR.	S/N CODE
W 7	Outer Wing Upper Surface	Wing Planks under nacelle skate angles	Crack\ up to three inches in length have occurred under the in board and outboard skate angles of the Inboard nacelle.	37	A
W 8	Outer Wing Upper and Lower Surfaces	Fuel Tank Access Door Lands	Corrosion has been reported on lower wing plank access door lands duo to condensation.	38	A

7	9		10
M E T H O D O F I N S P.	R E C O M M E N D A T I O N S		
	F R E Q U E N C Y O F I N S P E C T I O N	T Y P E O R M E T H O D O F R E P A I R	
V i s u a l ( E x t e r n a l , I n t e r n a l ) X-Ray	Initial external inspection at 450 flt. hrs. with repeat at next 450. Initial internal inspection at 900 flt. hrs. with repeat at 3000 hr. intervals. Discontinue inspections after 6000 hrs. if no cracks found.	(1) Repair cracks in planks per Electra Structural Repair Manual, Section 57-2-I.  (2) Install skate angle attachment reinforcement at inbd. and outbd. nacelles per LAC Alert Service Bulletin 88/SB-600A (Ref: LAC Dwg. 841481).	Same as Column 9, Item (2).
V i s u a l	Within next 850 flt. hrs. Reinspect at each overhaul period.	Remove corrosion per Electra Structural Repair Manual Section 51-2-14 and add protective coating per LAC Service Bulletin 88/SB-606. Repair per LAC Drawing 841295 when damage exceeds .010 inch depth.  NOTE: Contact LAC for repair of damage which exceeds allowable limits of Dwg. 841295.  (Refer to 88/SB-620G for access door gap sealing instructions.)	Add protection per 88/SB-606. Refer to 88/SB-620G for access door gap s e a l i n g instructions.

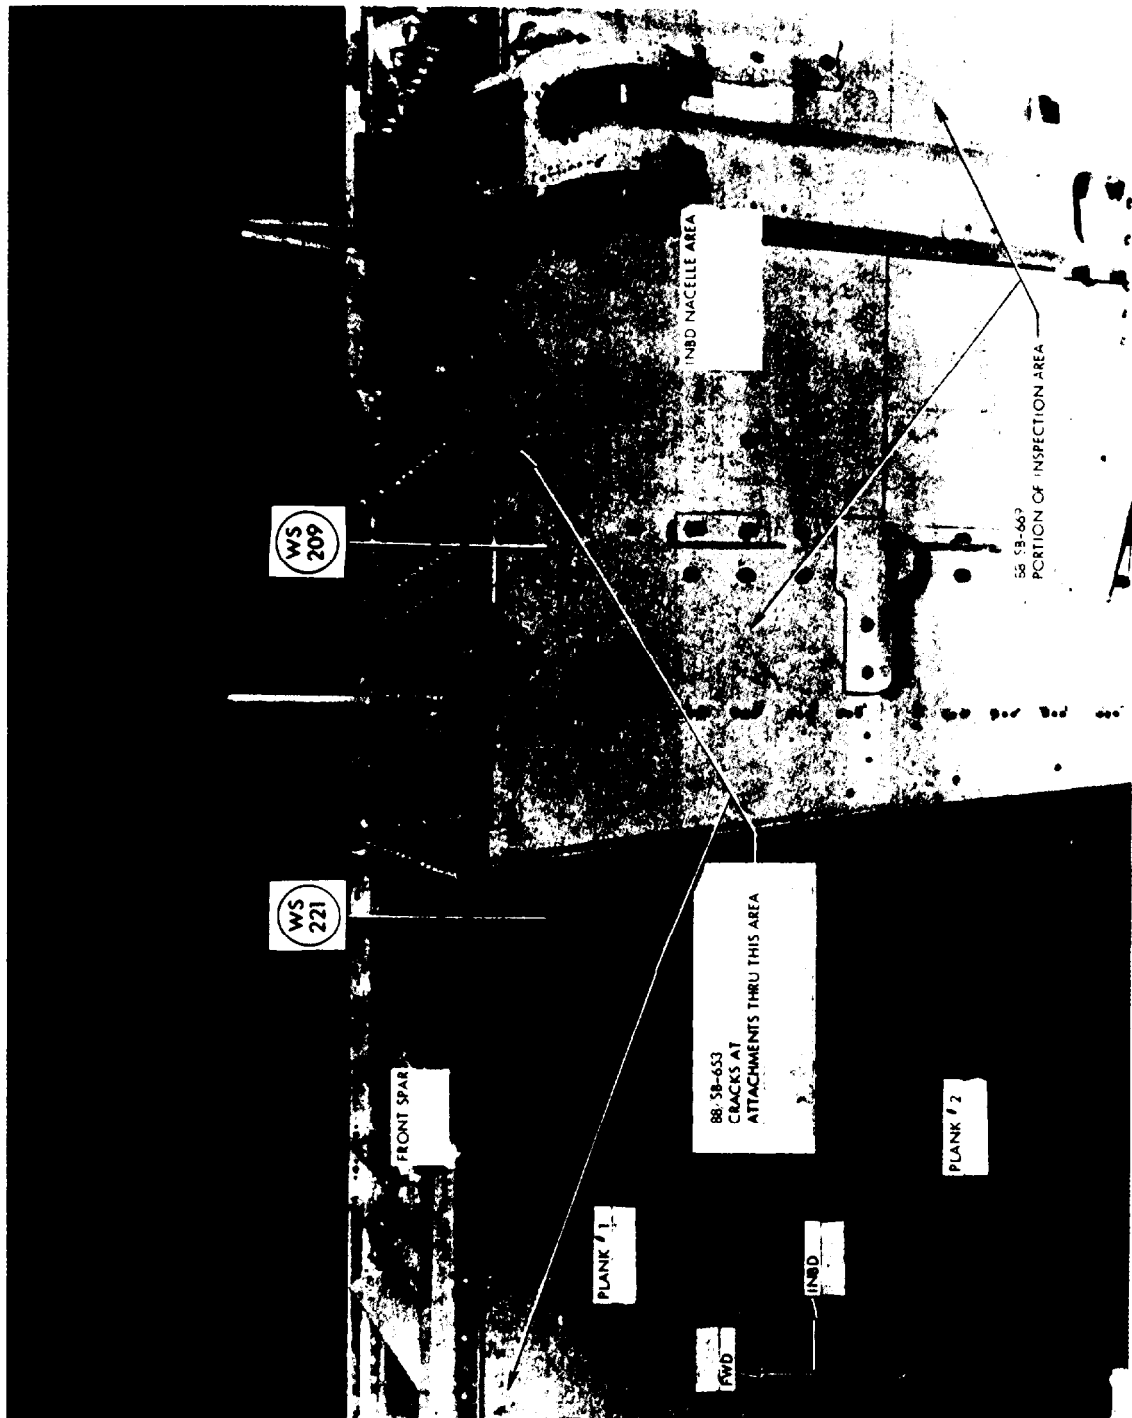
FIGURE F-29. WING LOWER SURFACE  
Reference W-22, page 20  
W-26, page 24

1	2	3	4	5	6
NO.	MAJOR ASSEMBLY	ITEM	SERVICE HISTORY	PAGE REF. FOR IL LUST.	S/N CODE
W-26	Outer Wing Lower Surface W.S. 157 to W.S. 219	Wing Planks Nos. 1 thru 3	Cracks have occurred in the lower wing planks in the vicinity of the Main Landing Gear ribs at W.S. 167 and 209.	35 44 54 55	A
W 27	Outer Wing Front Spar W.S. 168	Upper Cap and Spar Web	Cracks have occurred in upper spar cap vertical leg and in web at rib attach bolts at W.S. 168.	50 51	A
W 28	Outer Wing Upper Surface	Wing Planks Nos. 2 to 4 on each side of inboard racelles	Cracks have occurred in upper wing planks 2, 3, and 4 in skate angle area.	56	1
w 29	Outer Wing Upper Surface W.S. 346	Wing Planks No. 1 thru 5 at inboard side of outboard racelles	Cracks have occurred in upper wing planks No. 1 thru 5 at W.S. 346.	30	⚠

7	8	9	10
METHOD OF INSP.	RECOMMENDATIONS		PREVENTIVE ACTION
	FREQUENCY OF INSPECTION	TYPE OR METHOD OF REPAIR	
Visual and Dye Penetrant	Initial Inspection within the next 400 hours time in service unless previously accomplished. LAC Service Bulletin 88/SB-669A for detailed instructions.  Repeat inspections within 2500 ft. hours or 2500 landings whichever comes first.	Per listed repair installations in accordance with LAC Service Bulletin 88/SB-669A.  <u>INSTALLATION</u> <u>PLANK</u>  No. 841634      No. 1 & 2 841635      No. 1 841636      No. 3, 4, 5 841642      No. 5 & 6 841865      MLG Drag Strut Area	Same as Column 9.
Visual, Eddy current	On aircraft having 20,000 ft. hours or more inspect within 625 ft. hours. Repeat inspection at 1250 ft. hour intervals until preventive reinforcement or repair which eliminates repeat inspections is installed.	Repair in accordance with LAC Service Bulletin 88/SB-670D, paragraph 2.E.  <u>DRAWINGS</u> 8416248 841738A 84 17430 8418068	Service Bulletin 88/SB-670D paragraph 2.D. Ref Dwg. 841717E
